Albertson Engineering Inc.

RE: Modular Classroom Units
 Structural Review
 New Underwood, South Dakota
 Albertson Engineering File #2024-385

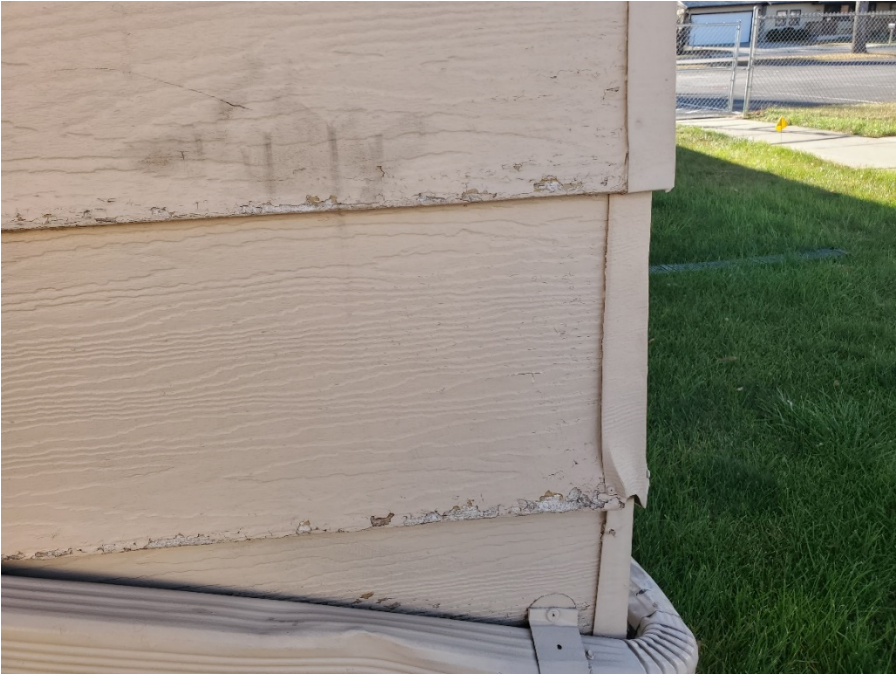
Photograph 1 shows an annotated aerial image of the four Units currently located at Canyon Lake Elementary School. These Buildings are labeled 1-4 for ease of reference. The structural observations focused mainly on the interior condition of the Buildings since the exterior issues were typically architectural items as shown in Photograph 2. No signs of moisture infiltration were observed on the interior spaces.

Photograph 2: Siding blemishes on Building 4. Similar siding deterioration was noted on the other units.

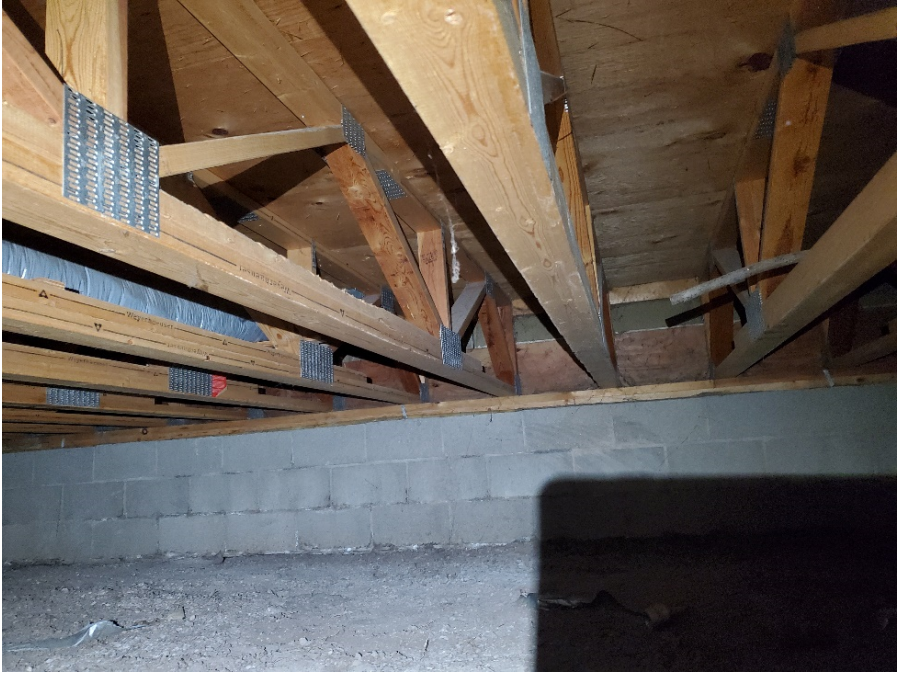
- The floor trusses in Buildings 1-4 were found in fair condition with no signs of mold or deterioration observed. Photographs 3 and 4 show the typical truss layouts with Units 1 and 2 having the same floor truss configuration and Units 3 and 4 sharing a truss configuration.

Photograph 3: Typical floor trusses from Buildings 1 and 2.

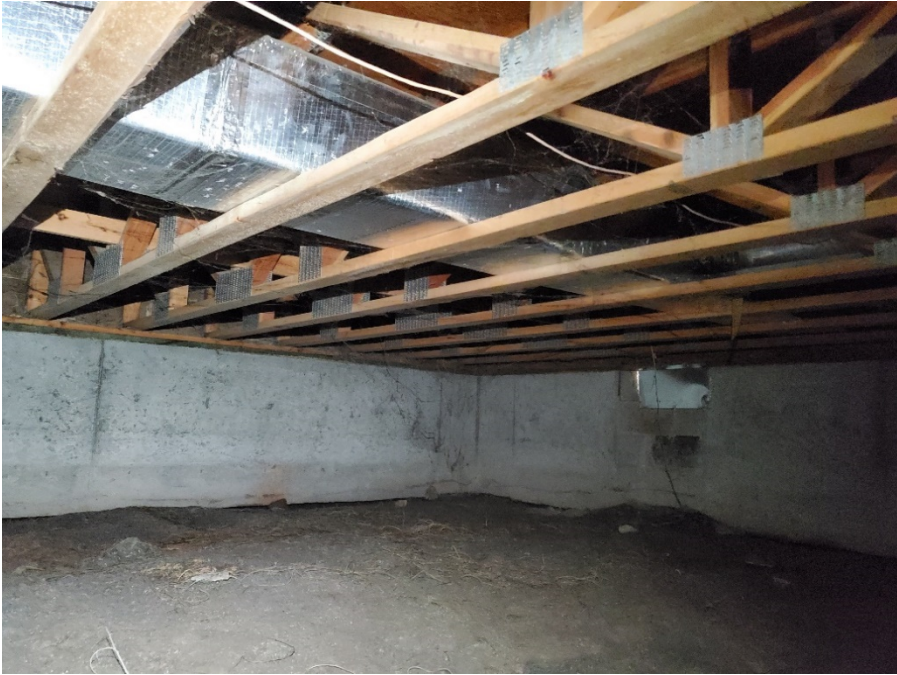
Photograph 4: Typical floor trusses from buildings 3 and 4.

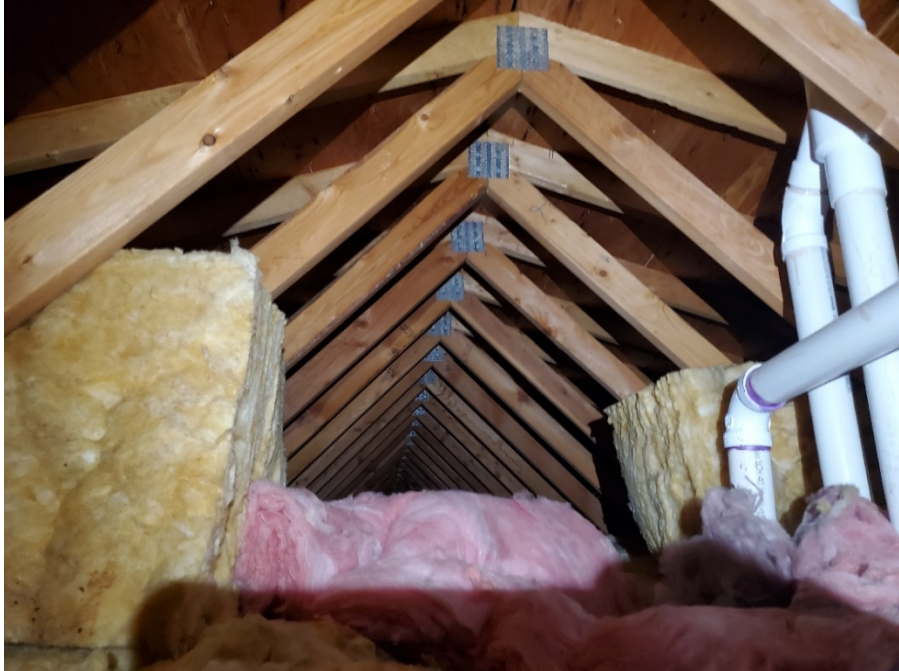
- No signs of water damage were observed at the truss bearing locations.
- The roof trusses in Buildings 1-4 were found in fair condition with no signs of mold or deterioration observed. Photograph 5 shows a typical roof truss arrangement applicable to all the Units.

Photograph 5: Typical Roof truss applicable to Buildings 1-4.

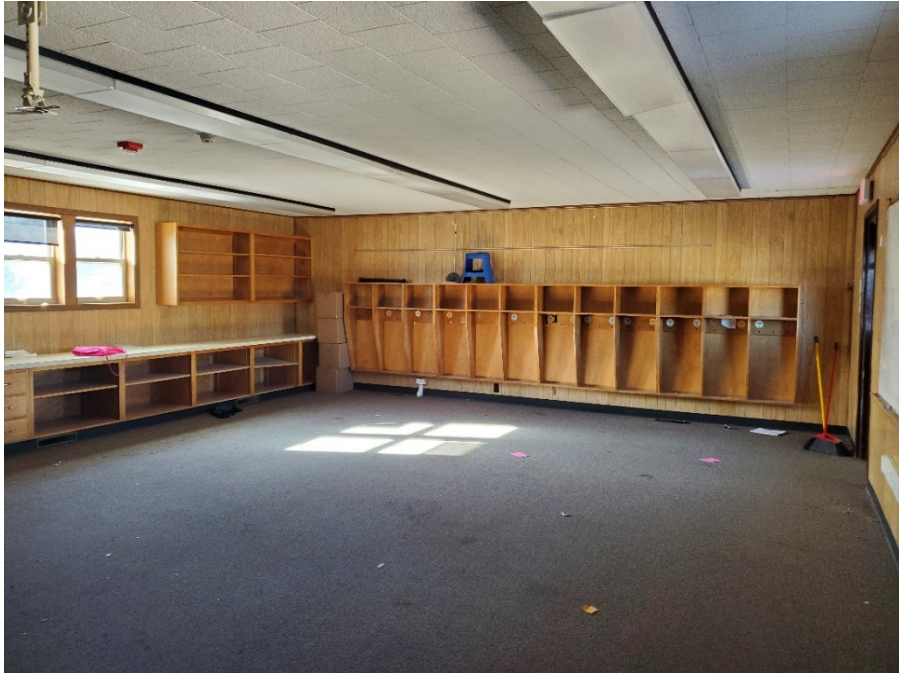
- Photograph 6 shows a typical classroom space within the Buildings. No signs of moisture damage or water staining were noted on the ceiling finishes.

Photograph 6: Typical classroom space. No signs of water staining were noted in the ceiling finishes.

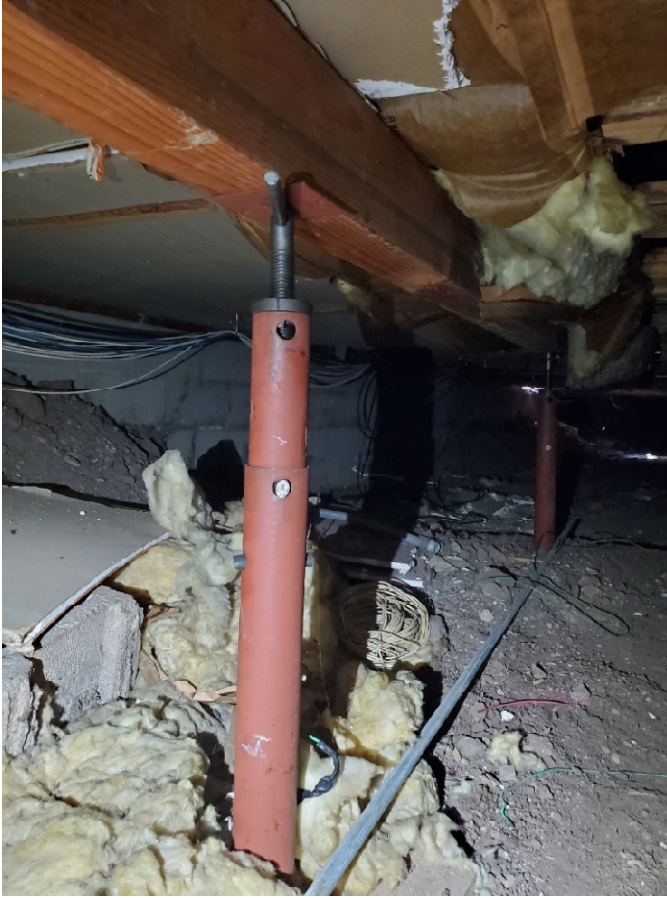
- Buildings 1 and 2 both had extra beams installed under the floor trusses as shown in Photographs 7 and 8.
 - The Building 1 support beam is supported by three pipe jacks that bear on top of sheets of plywood in direct contact with the dirt floor.

- The Building 2 support beam is also supported by three pipe jacks that bear on small concrete footings.
 - The reason for these support beams is unknown. The supported floor trusses in each building do not appear to show signs of distress when compared to the other non-supported trusses.

Photograph 7: Beam under floor trusses in Building 1.

It is unknown why Buildings 1 and 2 each have additional interior support beams present. The Rapid City Area Schools likely noted sagging in these buildings and took corrective action. However, no one with the district can provide a reason or information on when these beams were installed. AEI anticipates designing two new interior support beams as part of the new building foundations for the next phase of this project.

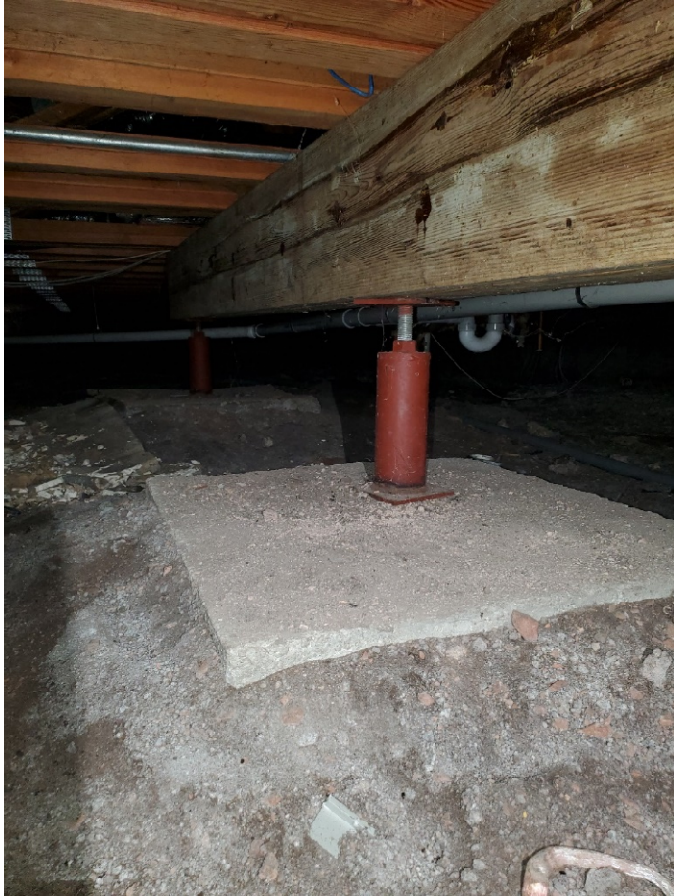
Photograph 8: Beam under floor trusses in Building 2.
