Albertson Engineering Inc.

RE: Modular Classroom Units
 Structural Review
 New Underwood, South Dakota
 Albertson Engineering File #2024-385

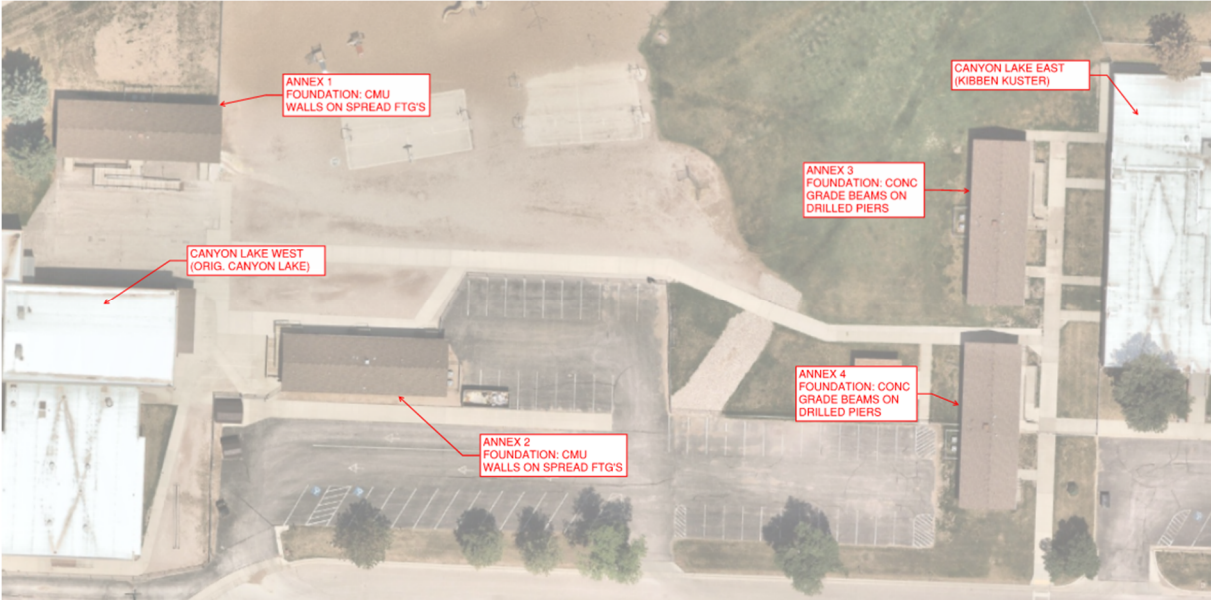
Photograph 1 shows an annotated aerial image of the four Units currently located at Canyon Lake Elementary School. These Buildings are labeled 1-4 for ease of reference. The structural observations focused mainly on the interior condition of the Buildings since the exterior issues were typically architectural items as shown in Photograph 2. No signs of moisture infiltration were observed on the interior spaces.

Photograph 1: Aerial image of the four units currently at Canyon Lake Elementary. The unit numbers are shown for reference.
